# Littelfuse Arc-Flash Relay Saves Plant from Catastrophic Damage

## CASE STUDY

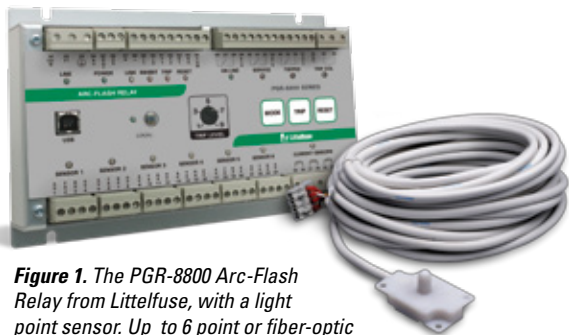
**Figure 1.** The PGR-8800 Arc-Flash Relay from Littelfuse, with a light point sensor. Up to 6 point or fiber-optic sensors can be used per relay.

Deschamp installed the Littelfuse PGR-8800 Arc-Flash Relay in the controls section of the cabinet, with two light sensors mounted in each of the three power compartments. The trip output of the relay was connected to the shunt trip input of the main breaker.

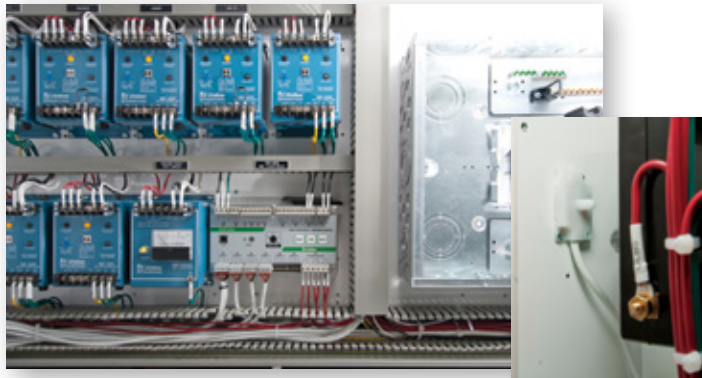
**Figure 2.** Typical installation of the PGR-8800 Arc-Flash Relay and the light sensor.

As the arc reached the cabinet, all six of the light sensors reacted to the bright arc-flash light, even the ones that didn't have a direct line of sight. The arc-flash relay responded immediately, sending a trip signal to the main breaker in less than 1 ms. Deschamp was able to confirm this as each sensor shows its trip status. Without the PGR-8800, the main breaker would not have reacted fast enough to stop the catastrophic arc flash. Instead, damage was minimal: a thumb-sized piece of metal was burnt off one of the bus bars. The cabinet and the switchgear inside suffered only minor damage.
