Littelfuse Arc-Flash Relay Saves Plant from Catastrophic Damage

CASE STUDY

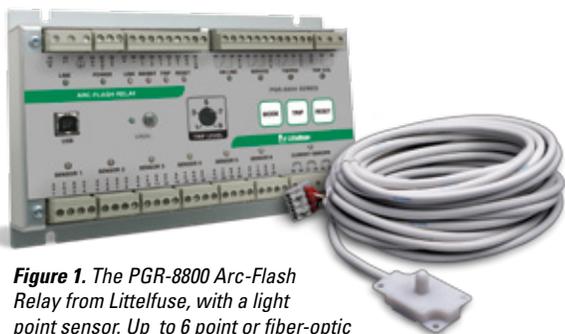
Figure 1. The PGR-8800 Arc-Flash Relay from Littelfuse, with a light point sensor. Up to 6 point or fiber-optic sensors can be used per relay.

Deschamp knew that to be able to work on the cabinet or lower required PPE, he needed to find a way to lower the HRC. He selected the PGR-8800 Arc-Flash Relay from Littelfuse, which could be easily retrofitted in to the existing cabinet. This device can lower incident energy by detecting a developing arc flash and sending a trip signal to the breaker within 1 ms. Deschamp was wary of durability and maintenance problems that he had experienced with other relay manufacturers and wanted a solution that would be both reliable and easy to maintain.

Deschamp installed the Littelfuse PGR-8800 Arc-Flash Relay in the controls section of the cabinet, with two light sensors mounted in each of the three power compartments. The trip output of the relay was connected to the shunt trip input of the main breaker.

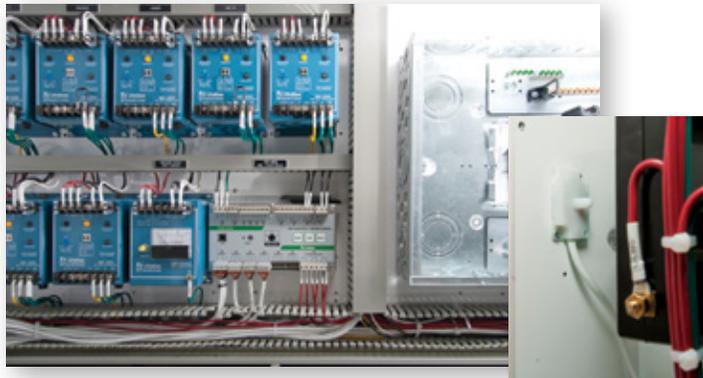
Figure 2. Typical installation of the PGR-8800 Arc-Flash Relay and the light sensor.

As the arc reached the cabinet, all six of the light sensors reacted to the bright arc-flash light, even the ones that didn't have a direct line of sight. The arc-flash relay responded immediately, sending a trip signal to the main breaker in less than 1 ms. Deschamp was able to confirm this as each sensor shows its trip status. Without the PGR-8800, the main breaker would not have reacted fast enough to stop the catastrophic arc flash. Instead, damage was minimal: a thumb-sized piece of metal was burnt off one of the bus bars. The cabinet and the switchgear inside suffered only minor damage.
