Littelfuse Startco
PGR-5701 Ground Fault Monitor
With
Variable Frequency Drive

Test Report

Executive Summary

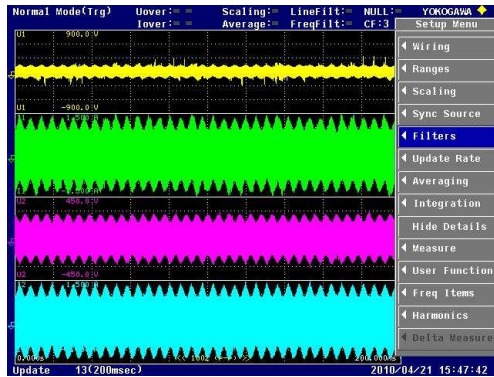
Non-filtered and filtered ground-fault (EL1) and NGR (EL2) currents and voltages were measured by the power analyzer. See Figs 1 and 5. The power analyzer has an internal selectable 500 Hz low-pass filter. Application of the filter was necessary as the unfiltered signals contained large amounts of noise, making waveforms difficult to visualize. This is seen in an example ground-fault with a 1-A fault current at 10-Hz fundamental frequency. See Figs. 10 and 11.

From top to bottom, the waveforms are; line-to-ground voltage, ground-fault current, NGR voltage, and NGR current.

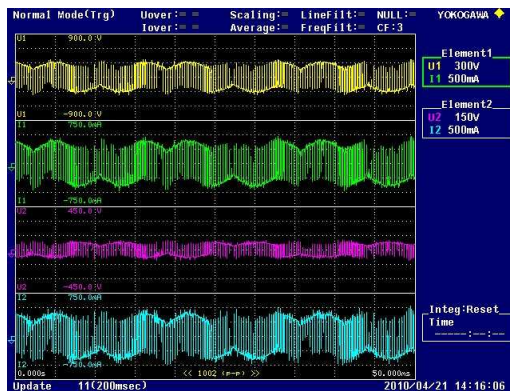
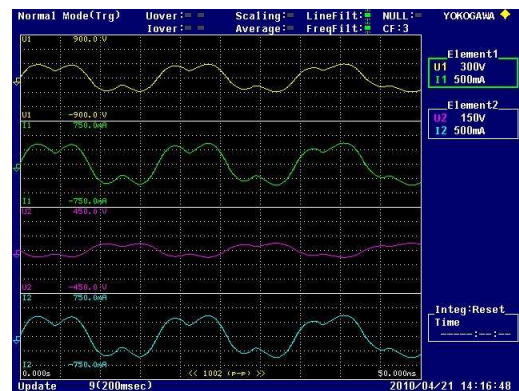
The unfiltered currents measured by the power analyzer, EL2 NF and EL1 NF, are similar to the values of the Fluke RMS meters, while the power analyzer filtered values, EL2 and EL1, are similar to the PGR-5701 analog output values. The waveforms in Figs. 12 and 13 were captured for the filtered and unfiltered fault currents from the power analyzer.

It can be seen from the waveform captures that the fault current contains many harmonic components. With the 500 Hz filter applied, a 180-Hz ripple current can be seen superimposed over the 60-Hz drive output. This 180-Hz ripple current was observed in all subsequent tests at various output frequencies.

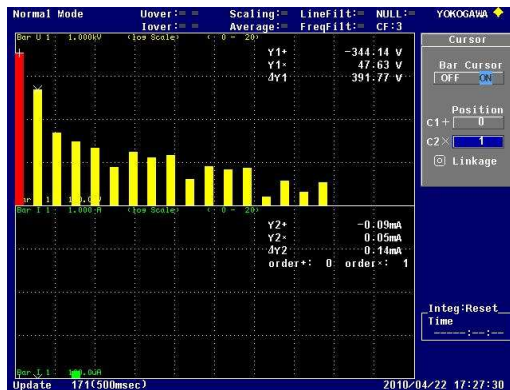
A spectrum analysis of the negative DC bus fault yielded the output shown in Figs. 16 and 17.

The 180 Hz component of fault current is 13.7% of the total fault current.

The DC fault spectrum analysis in Fig. 17. shows the 180 Hz amounts to 10-15% of the fault. Therefore, if it is desired to have a PGR-5701 trip on a DC-bus fault it is recommended that the pickup level be set to 10% of the NGR let-through current. (This assumes that the measured-feeder charging current is less than 10% of the NGR let-through current, or the PGR-5701 could sympathetic trip when a ground fault occurs elsewhere on the system.)

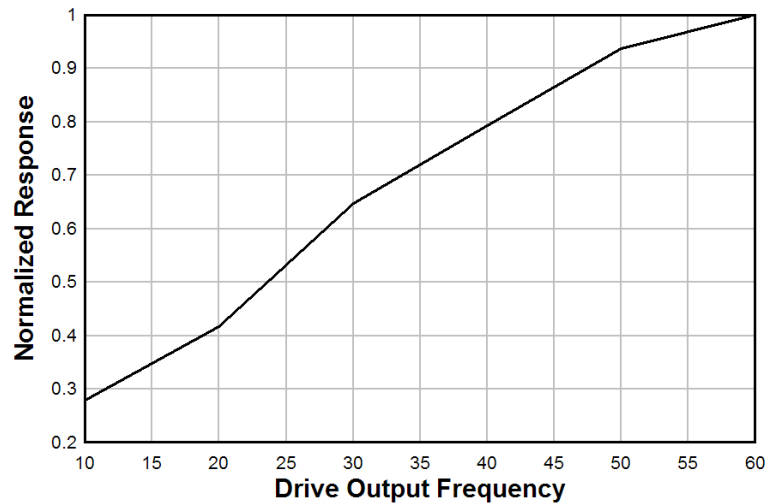
Figure 18. PGR-5701 Frequency Response, Peak Detection Filter

Testing of the PGR-5701 at various fault frequencies was completed using both the DFT and peak filter selection of the PGR-5701. The results show that the bandwidth of the DFT filter is too narrow to be used in VFD applications in which the VFD operates below 50 Hz. The peak filter is a better choice in this type of application—its wider filter bandwidth allows the PGR-5701 to detect frequencies below 50 Hz. Even with the peak detection filter, frequencies below 50 Hz are attenuated. This frequency response is shown in Fig. 18.

From Fig. 18 a recommended setting for the PGR-5701 can be calculated based on the lowest expected operational frequency. This setting can be found by multiplying the desired trip level by the normalized response value at the lowest expected operational frequency.

Recommended setting = (desired trip level) x (response @ lowest frequency)

For instance, if a 1,000-mA RMS trip level is desired and the VFD will be operating at 40 Hz, the recommended PGR-5701 setting is 1,000 mA x 0.8 = 800 mA, or 16%.

When a PGR-5701 is used in a variable-frequency application, use the peak (variable-frequency) filter selection. This selection has a wider pass band and less attenuation at frequencies below 60 Hz. When used in these applications, a lower trip setting for the lower frequencies can be required due to the PGR-5701 frequency response. The lowest operating frequency expected should be considered and the normalized pick-up value from Fig. 18 should be used to calculate the appropriate trip level.

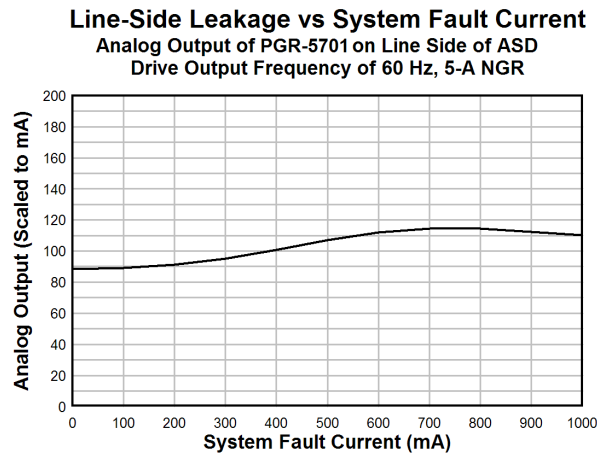
Figure 19. Line-Side Leakage vs System Fault Current

With a ground fault located upstream, a CT measures the charging current of the feeder downstream. This test was performed to determine what affect upstream-fault magnitude has on the measured charging current.

As can be seen in Fig. 19, an increase in upstream fault current has only a very slight effect on the level of charging current. The increase in charging current was not substantial enough to trip a PGR-5701.
